MS Bar Screen Solves Odor & Debris Issues at Water Reclamation Facility

Customer: Camrosa Water District
Industry: Water Reclamation

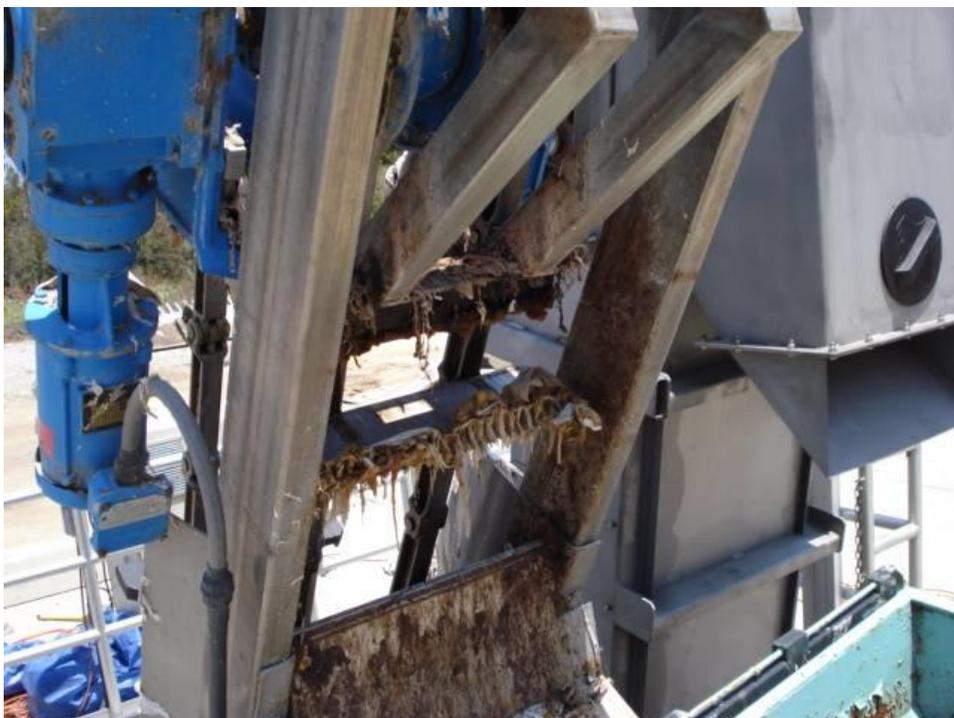
Debris collected on the old screen's chains and scraper mechanisms that frequently required cleaning

Also, due to a lack of lower bearing and cross members in the screenfield, the screen would build up with debris that would blind off portions of the screen. The debris against the bars would result in the bending of the rake fingers exacerbating the problem even more. The removal of this debris required someone to go down into the channel, a confined space entry. Since the screen was not enclosed, debris was spread across the plant's grounds, requiring additional cleaning. The mess and smell of sewage attracted swarms of flies making the working conditions unpleasant. The facility personnel realized the screen needed to be replaced.
