Simcoe is the largest town in the Norfolk County, located in the Southwestern part of Ontario, Canada. Having determined that upgrades to the existing facility were required, one of Canada's leading design engineering firms in the wastewater treatment field, RV Anderson & Associates Ltd, was contracted to perform the design of this maximum flow, 13 million gallons per day (51,000 m³/d), plant.

In 2008, H2 Ontario was selected as the contractor for the project. The upgrades included the complete refurbishment of the preliminary treatment section of the plant. The design entailed the supply and installation of a new mechanical screen with bar spacing of 0.5 inch (13mm) that had to meet difficult and unique challenges at this application.

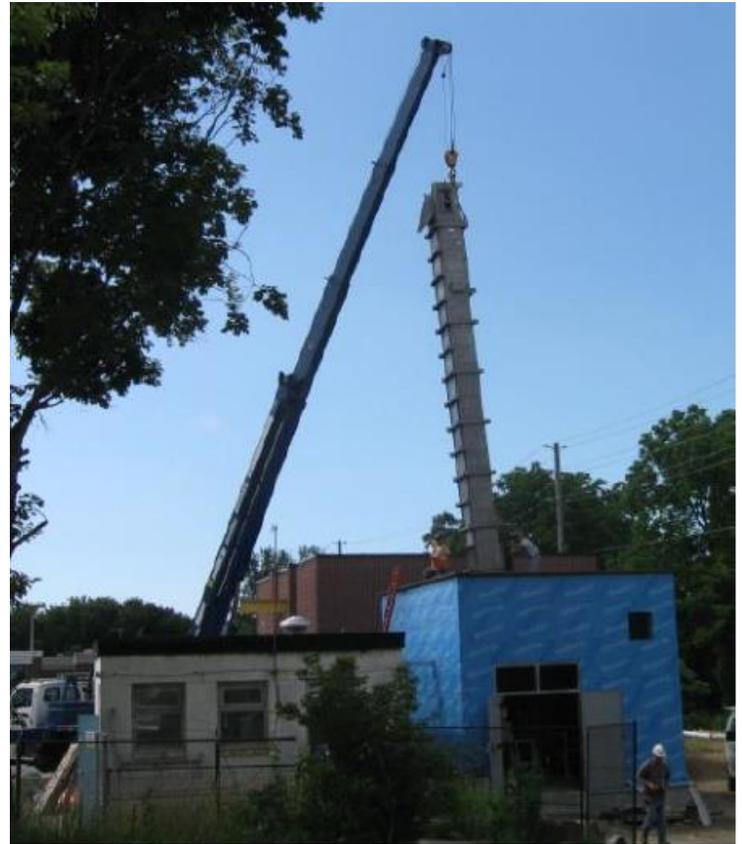
Installation of Headworks MS Bar Screen

were adversely affecting the biological processes. Additionally, the space available for the mechanical screen was extremely limited given the fact that this was originally not an open channel but a 3-foot (900 mm) diameter pipe located 25 feet (7.40m) below the operating floor. In order to accommodate the screen, it was necessary for the contractor to install a special steel box connected to the existing pipe, to which the bottom of the screen would then be attached.

The second factor was the limited space available in, around and above the new screen room. These restrictions made it necessary for the one-piece 31-foot (9.50m) long screen to be designed to rest at a 90-degree angle and installed through a specially designed hatch in the room's rooftop.
