Small but Powerful MS[®] Bar Screen Handles Prison Waste Effectively

Customer: Beto WWTP
Industry: Water Reclamation

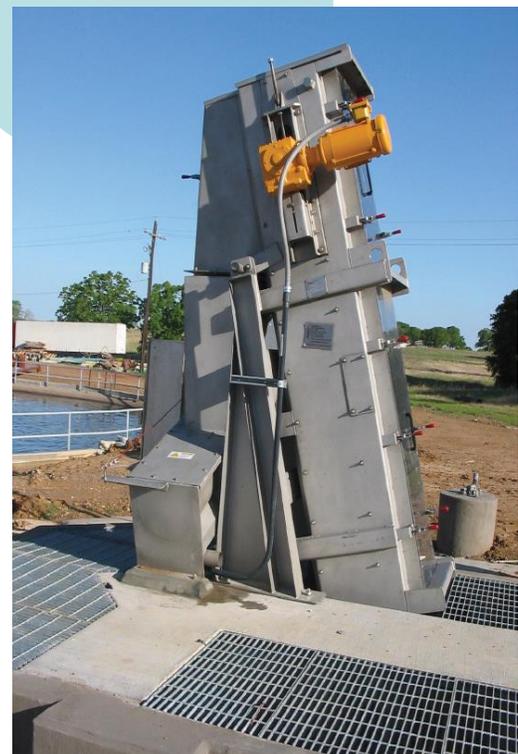
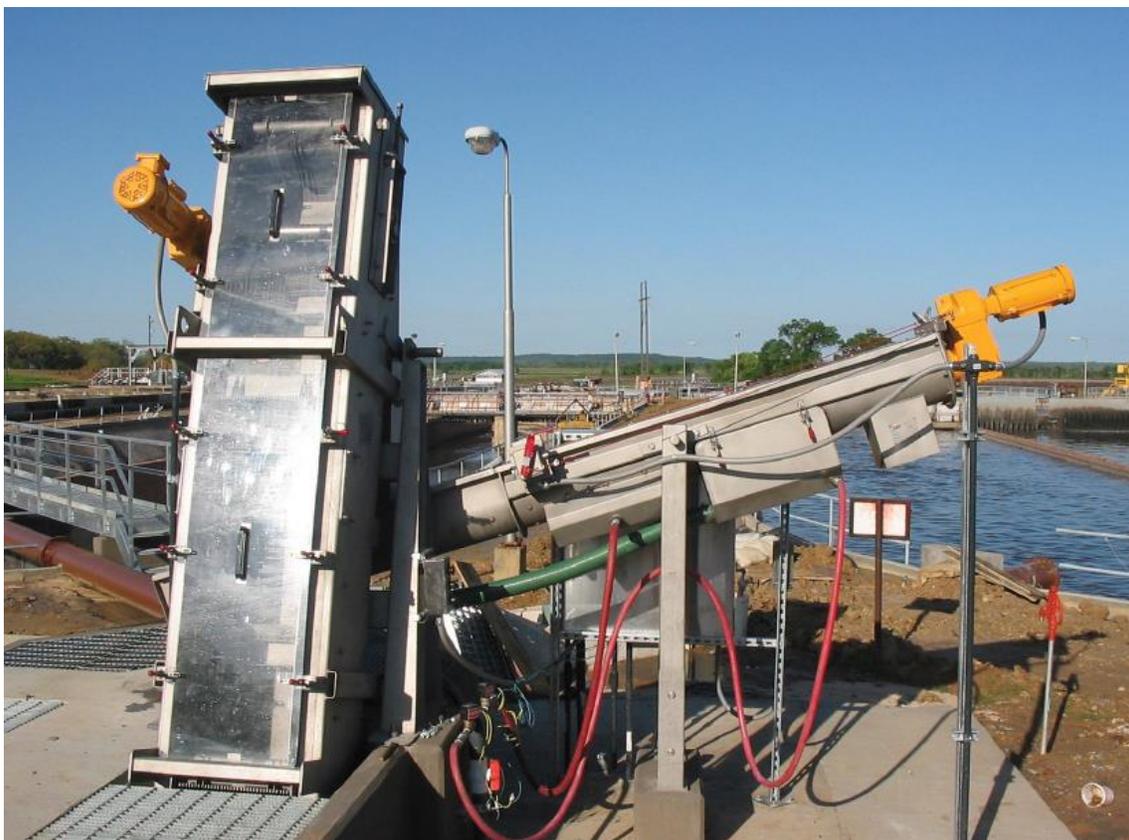
The screen which Headworks Inc. provided has an overall length of 13 feet 2 inches. The screen field length is 2.88 feet long and 1.52 ft wide. It weighs a whopping 2,015 lbs and is installed at an angle of 75°. The screenings are discharged into the chute of the Transpactor for dewatering and removal.
