Proof of Headworks MS[®] Bar Screen's Exceptional Durability

Customer: Cadiz Street Pump Station
Industry: Pump Station for Wastewater

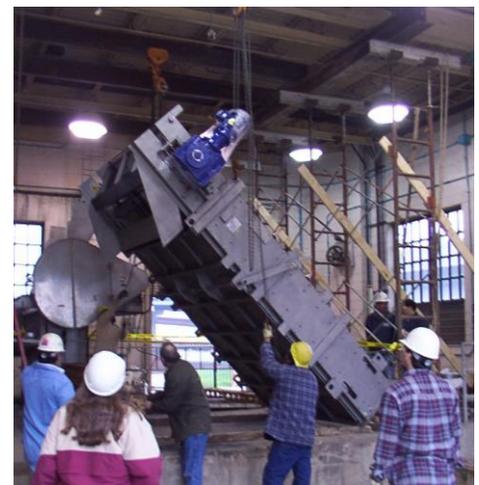
Headworks Bar Screen installed at the Cadiz Street Pump Station

The screens were designed with 1 inch (25 mm) bar spacing and each screen handles flows up to 80 MGD (300,000 m³/d) with a max water depth of 15 ft (4.6 m). The rapid five second cleaning cycle interval prevents the station from flooding while passing maximum flows with very little headloss.
