## MS™ Bar Screens Simplify Maintenance and Increase Tranquility

Customer: City of Los Angeles  
Industry: Water Reclamation

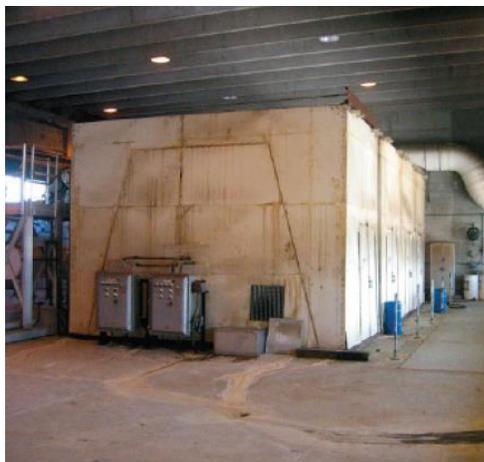
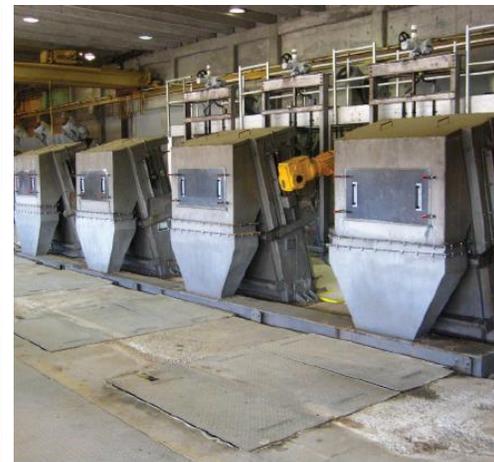
Before (left) and after (right)  
Tillman Water Reclamation Plant, Los Angeles

The solid construction of the stainless steel was an upgrade for DCT over the carbon steel of the previously installed models which became corroded in their hazardous environment. The multiple rake system that keeps a constant flow of debris and other material moving along was a strong selling point. Additionally, they viewed the variable drive system as a huge plus: the system automatically slows or speeds up to maintain an appropriate water level. Mr. Jhaj is pleased that the flow of material from the screen troughs and drain lines is constant, which prevents clogged lines. Another benefit is the patented self-reversing feature that automatically dislodges debris. The installation of the screens was a smooth custom fit to the existing space.
